Region 9 Enforcement Division
INSPECTION REPORT PHOTOGRAPH LOG
(Montecito Manor Apartments – 04/24/18)

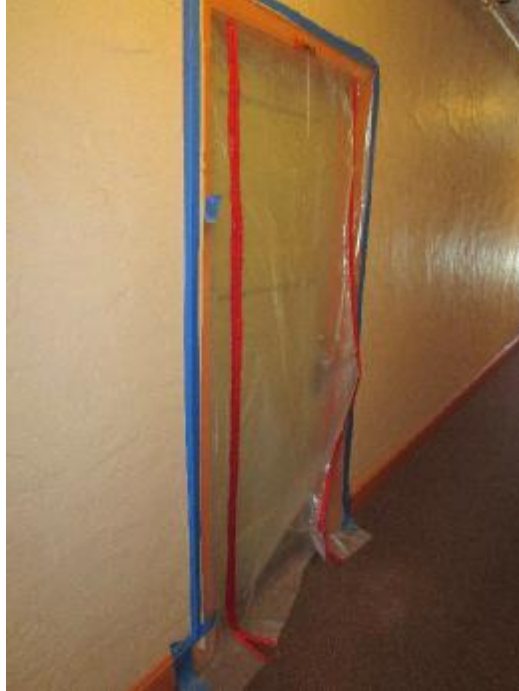
Photograph 1 (IMG_0009.JPG): A photo of the plastic sheeting placed on the front door of Unit 305.

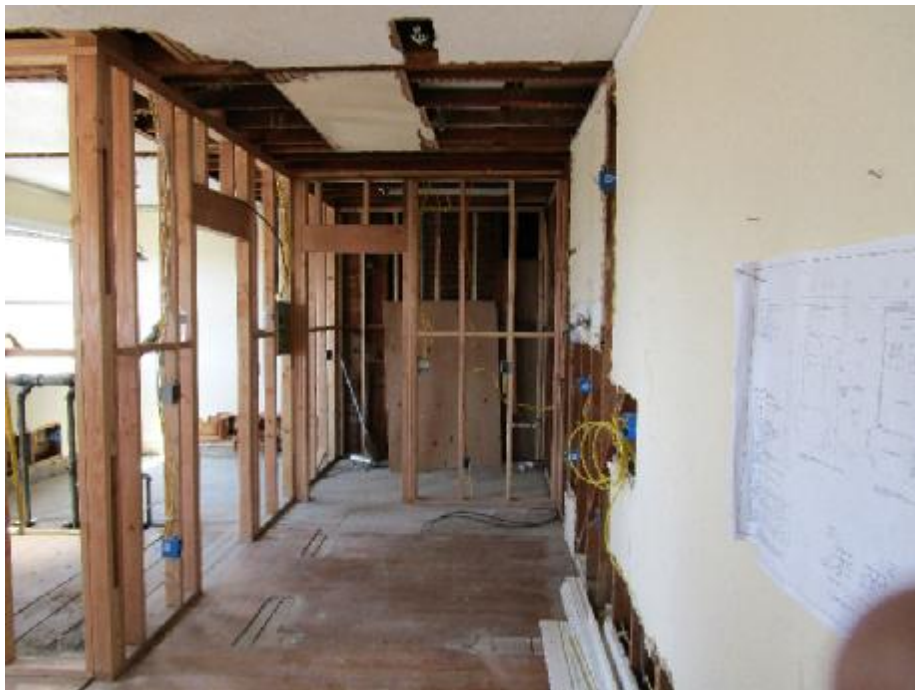
Photograph 2 (IMG_0012.JPG): A second photo of partially demoed walls in Unit 305. No plastic sheeting was secured to the floor to capture paint chips and debris during demo.

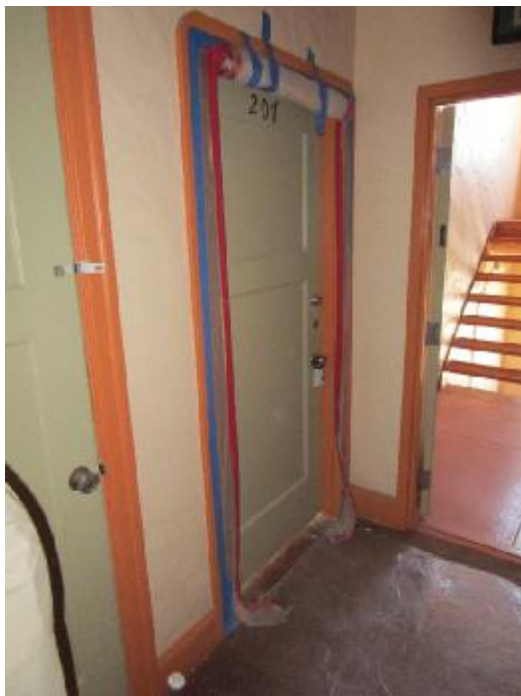
Photograph 3 (IMG_0021.JPG): A photo of the front door to Unit 207. The plastic sheeting is rolled up and taped to the door and no signage regarding the work was visible.

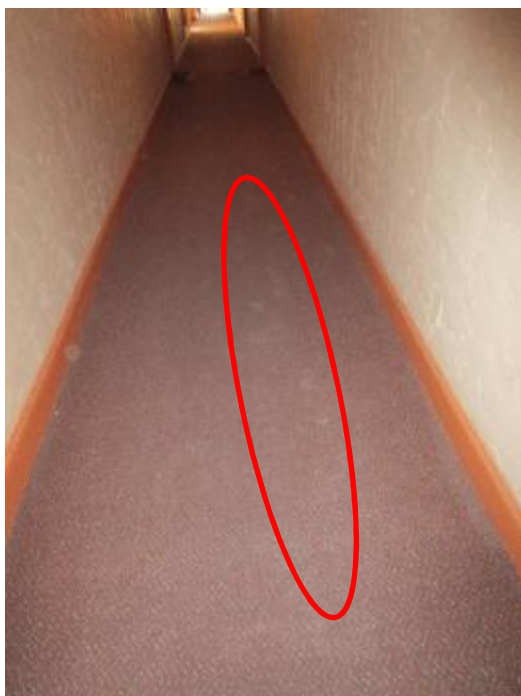
Photograph 4 (IMG_0024.JPG): A photo of the hallway right outside of Unit 207. Faint foot prints of paint dust can be observed being tracked from Unit 207 down the hallway of the building.

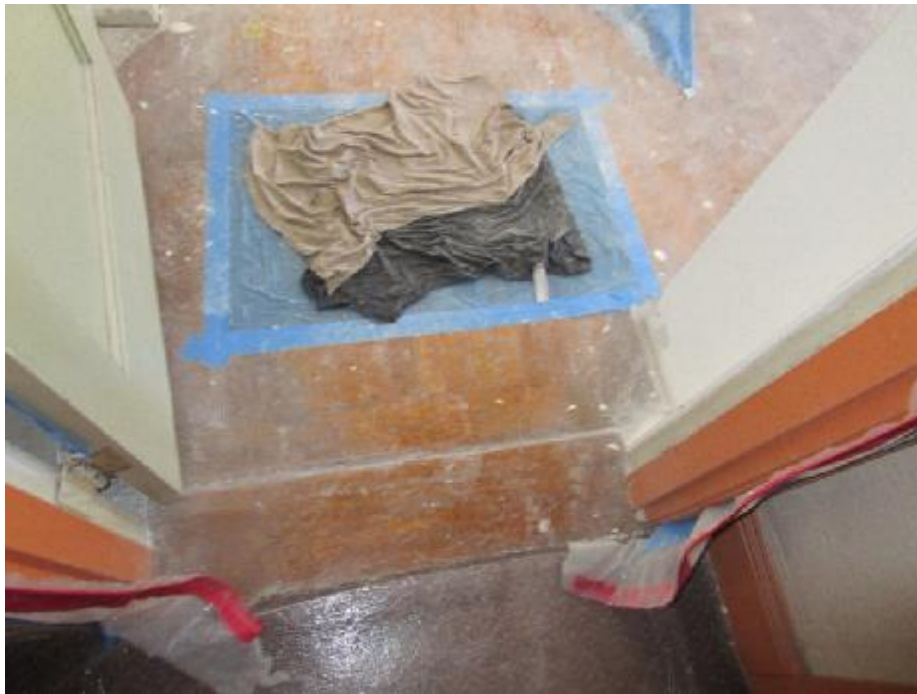
Photograph 5 (IMG_0025.JPG): A photo of rags on the interior floor of Unit 207. No plastic sheeting was secured to the floor to contain and capture paint chips and debris during the remodel.

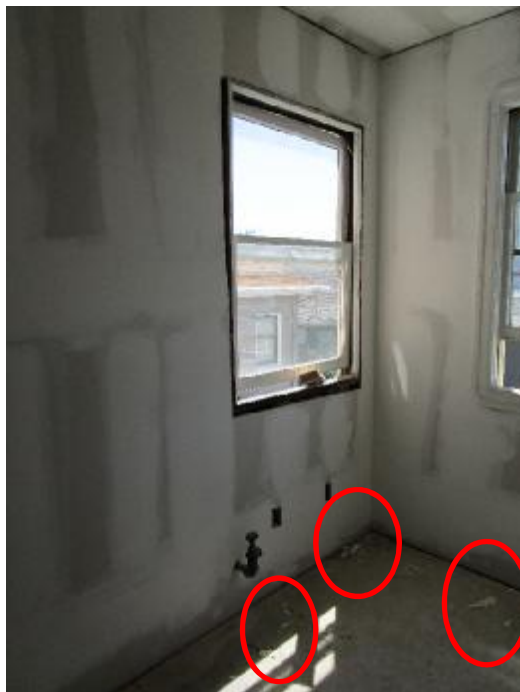
Photograph 6 (IMG_0026.JPG): A photo of an open window in a room being renovated in Unit 207. Paint chips were observed on the floor in the room.

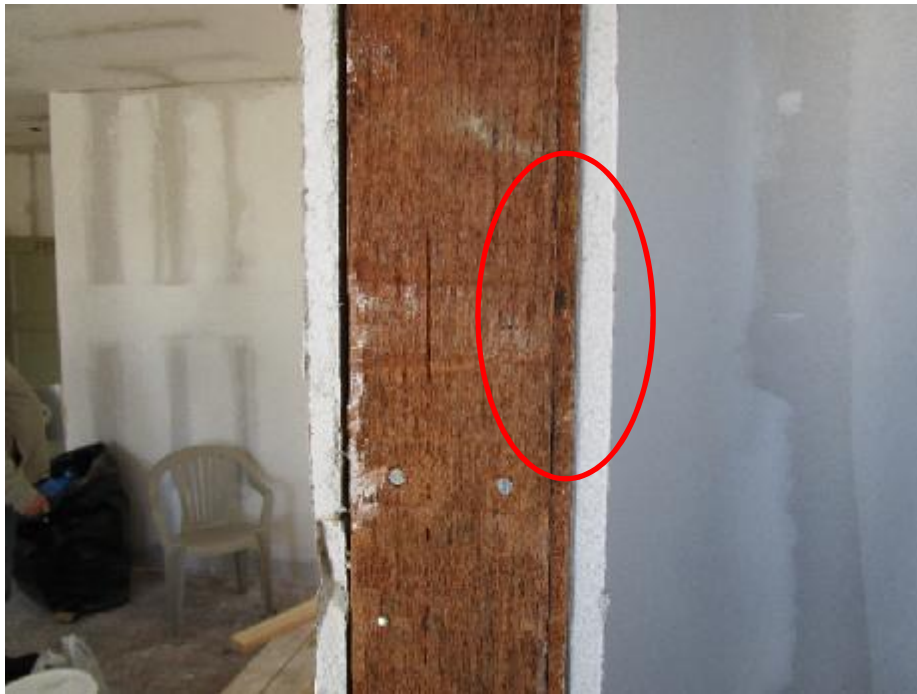
Photograph 7 (IMG_0031.JPG): A side view photo of a wall in Unit 207's bathroom. According to Mr. Mendez a new layer of drywall was placed on-top of the existing drywall (Right Side of the Wall) in the bathroom.

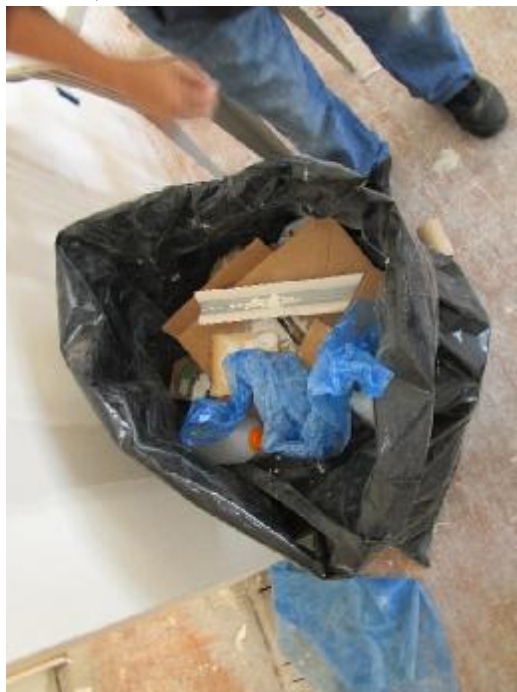
Photograph 8 (IMG_0032.JPG): A photo of an open trash bag containing paint waste and debris in Unit 207.

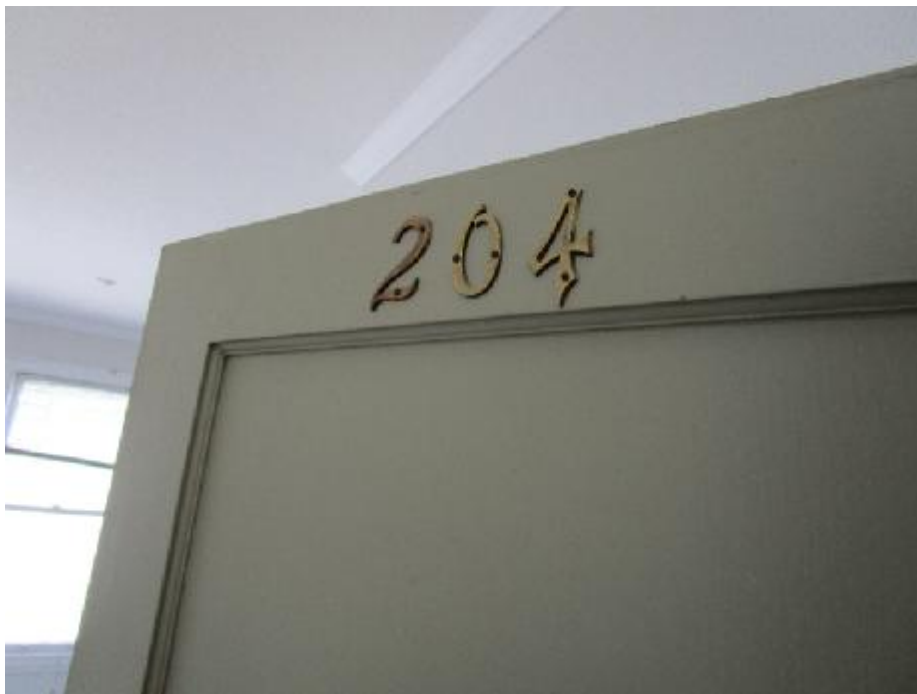
Photograph 9 (IMG_0036.JPG): A photo of the front door to Unit 204. EPA did not observe any signage regarding the work being performed in Unit 204.

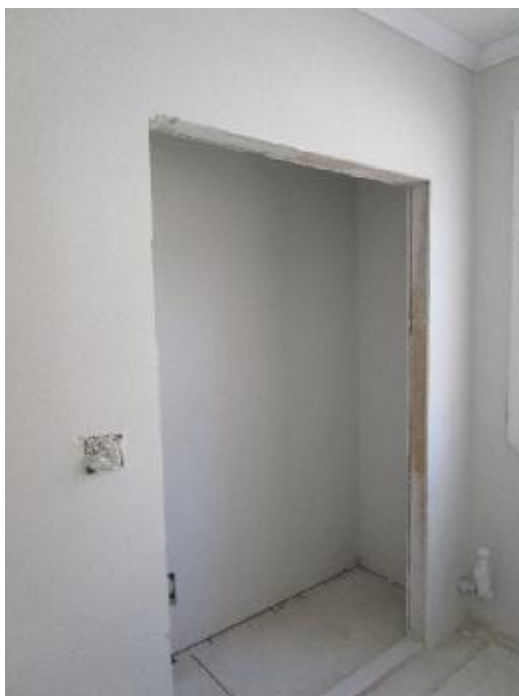
Photograph 10 (IMG_0038.JPG): A photo of an unfinished closet in Unit 204.

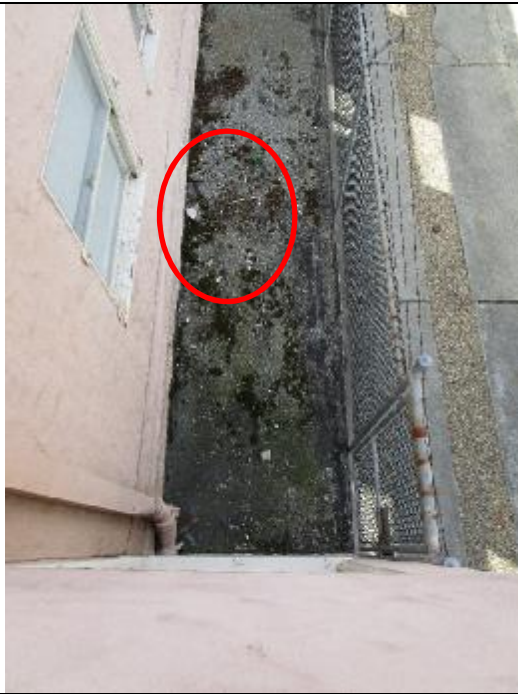
Photograph 11 (IMG_0047.JPG): A photo taken from Unit 202 of exterior paint chips on the ground directly below two units being renovated.

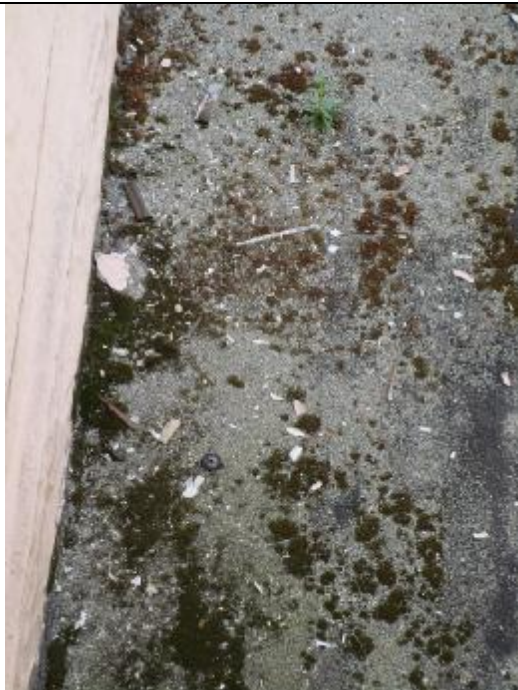
Photograph 12 (IMG_0048.JPG): A closeup photo taken from Unit 202 of exterior paint chips on the ground directly below two units being renovated.

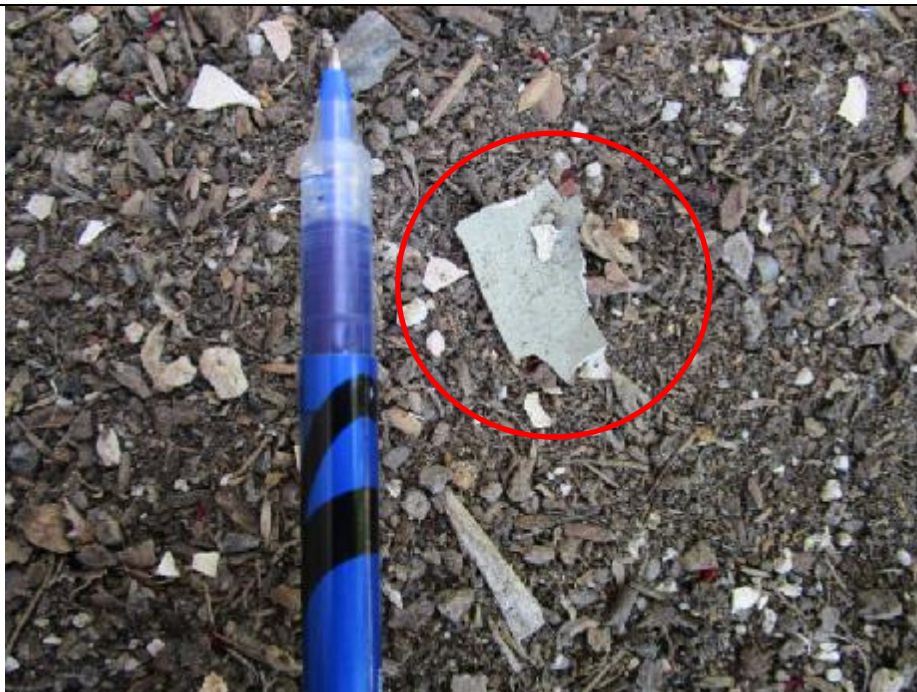
Photograph 13 (IMG_0066.JPG): A closeup photo of paint chips laying on the ground, outside and in front of the building. A large paint chip is next to the pen for scale.

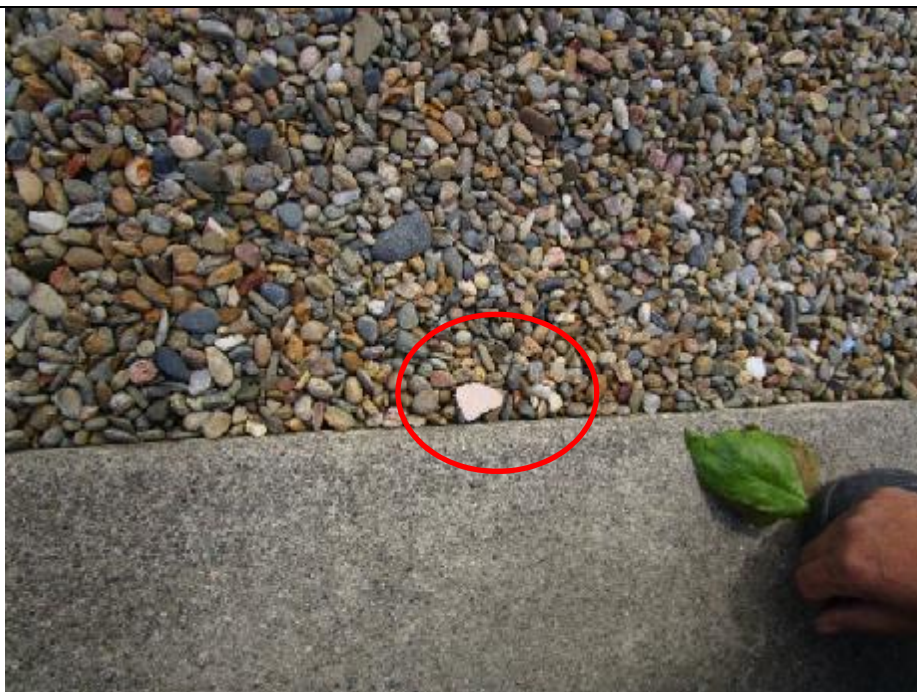
Photograph 14 (IMG_0070.JPG): A photo of a third paint chip laying on the ground in the neighboring parking lot adjacent to the building.
